PROTECTION OF AIRCRAFT FLUID SYSTEMS

LTV Aerospace Corporation

TECHNICAL REPORT AFML-TR-68-125

May 1968

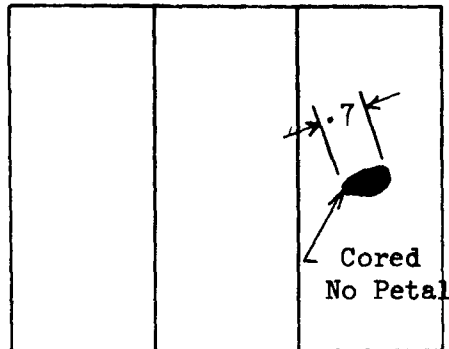
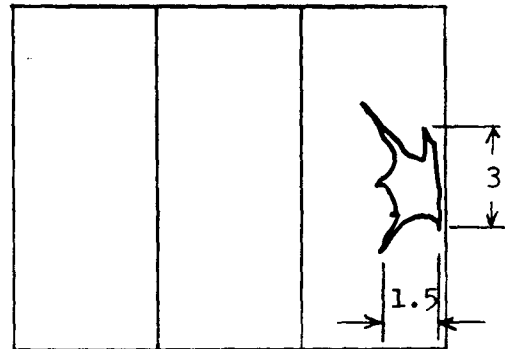
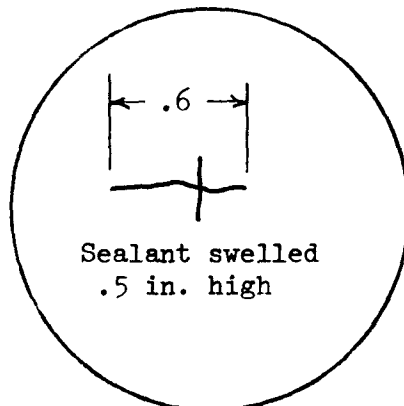
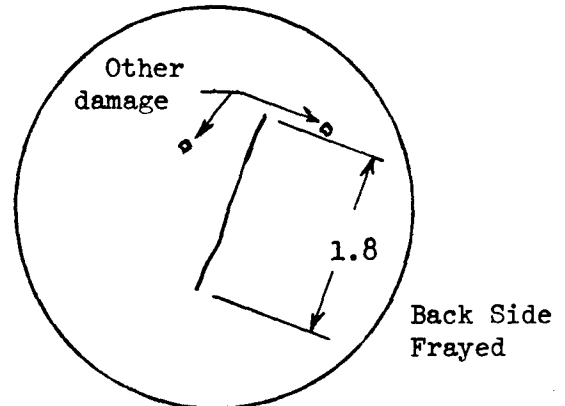
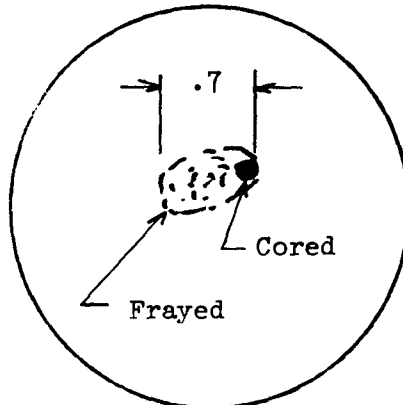
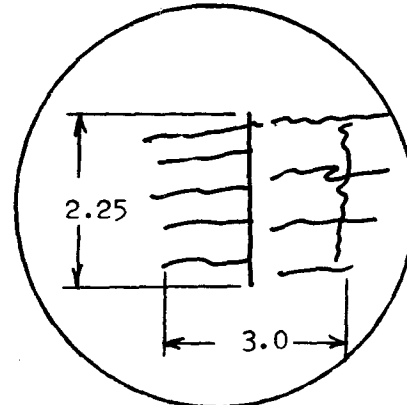
ROUND NUMBER T 72

The skin was cored .30 diameter and was petaled .2 inches high. The backing board was frayed .35 diameter. The self-sealing material suffered no damage and sealed damp immediately. Only a trace of fuel was present on the backing board.

The round hit the wood support and buried 1/4 inches deep. No skin was installed on exit side of the tank. Backing board deflected .5 inches and was frayed the size of the tumbled projectile. The self-sealing material slit and leaked a stream from the wound (dripping from structure) and slowed some in two minutes. Pressure was reduced to zero after 3 minutes; the wound sealed damp. When repressured, the wound seeped constantly in fast drips. The exit wound was slightly misaligned and would have been classed as a reduced rate leak.

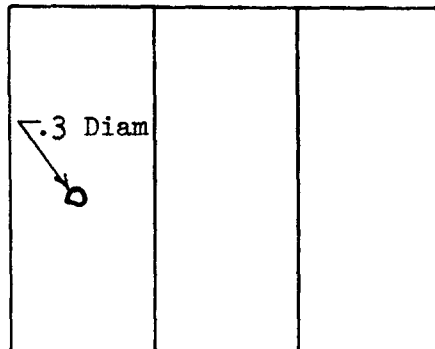
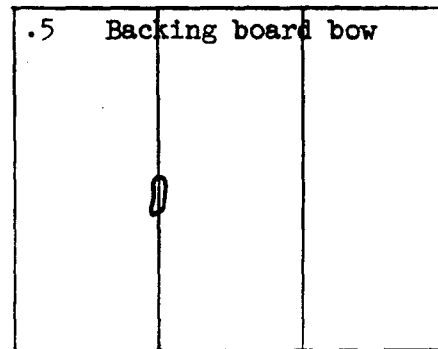
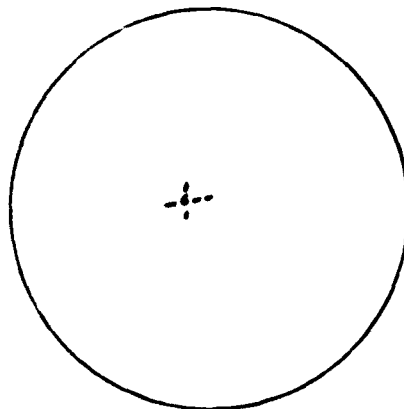
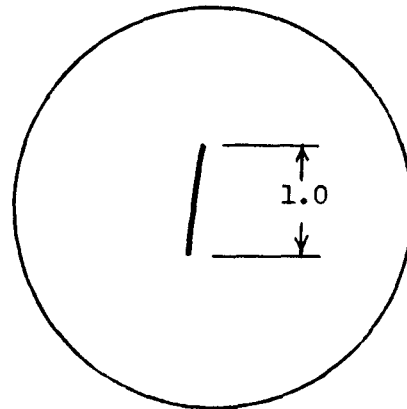
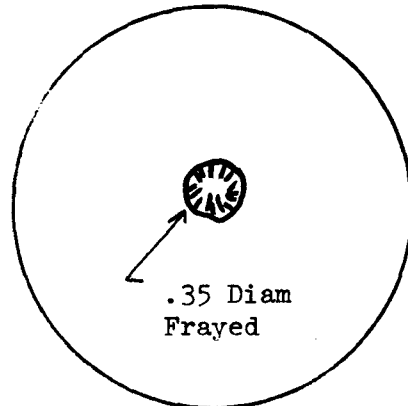
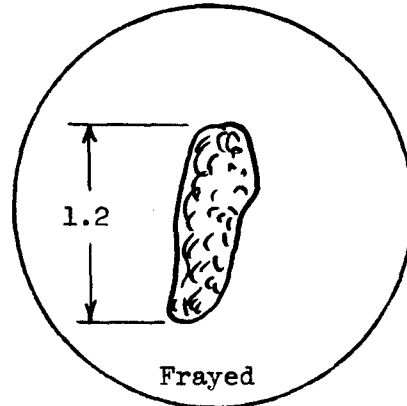
BLOCK NUMBER B 51  
 ROUND NUMBER T 73

The projectile broke up and the nose and another piece entered the cell separately. The skin was cored (Petals .2 inches) and the backing board frayed badly with slight coring. The self-sealing material was slit and leaked a stream the size of a pencil lead for 2 minutes 15 seconds before obtaining a damp seal at 2 psi. At 3 1/2 minutes, pressure was taken to zero and the wound sealed dry. Total leakage did not exceed 1/2 gallon.

Exit: Round struck the self-sealing material and just marked it.  
No damage; no exit.

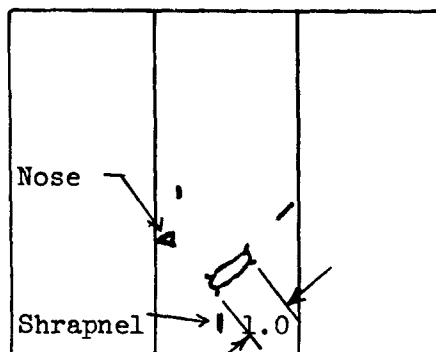
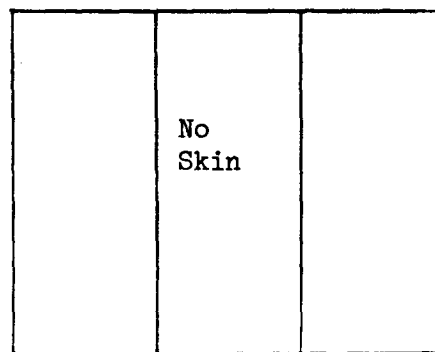
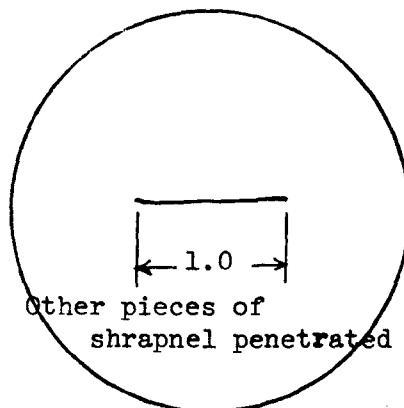
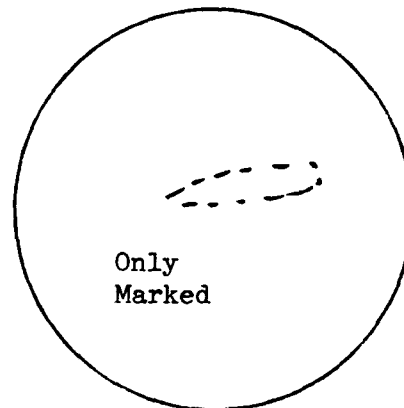
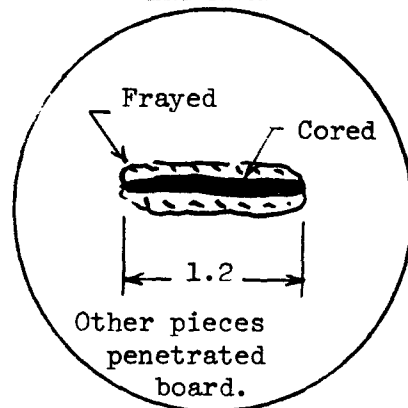
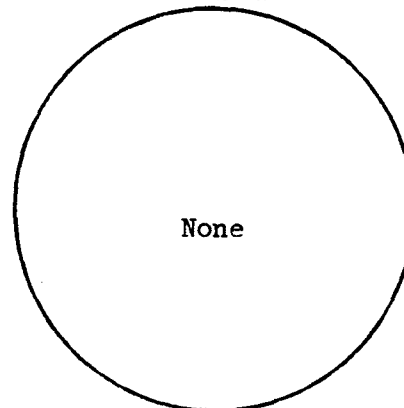
ROUND NUMBER T 74

The projectile traveled through the foam striking the rear self-sealing material (cutting it slightly) then bounced back into the foam approximately 4 inches. No other damage or leakage occurred.

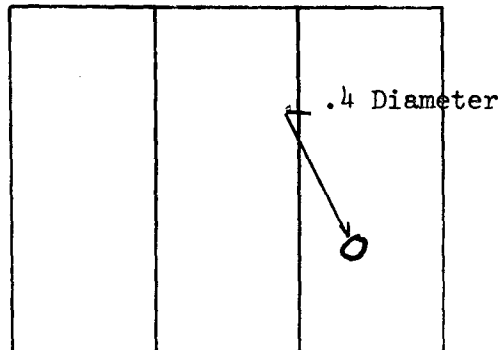
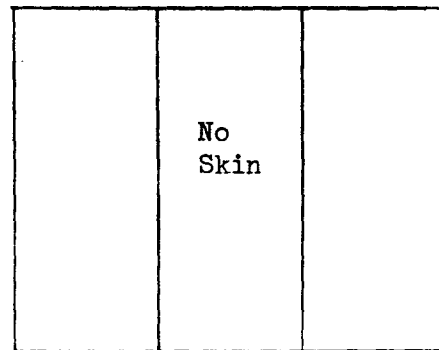
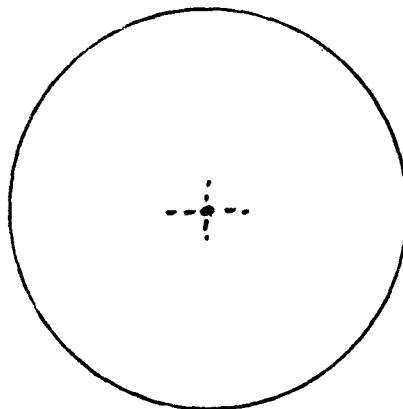
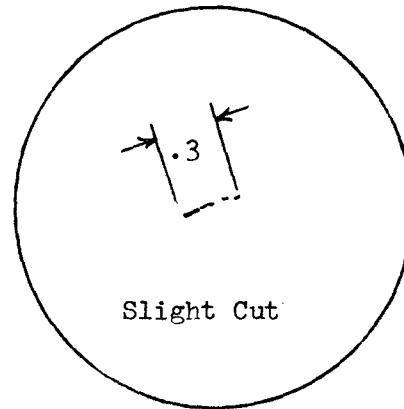
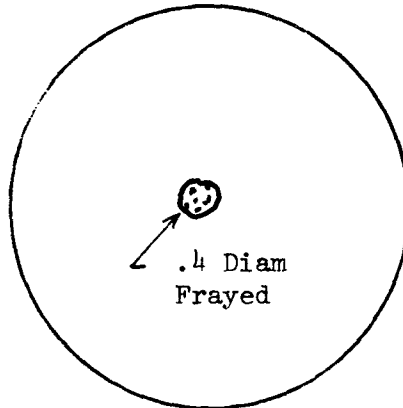
ROUND NUMBER T 75

No skin was installed on exit side. The backing board was frayed but no deflection occurred. The self-sealing material was slit with the wound misaligned. No seal occurred. The leakage was a stream about half the size of a pencil and would not slow in 3 minutes with 2 psi pressure. Reduced pressure to zero; leakage continued to flow down surface instead of spraying out. Classed as wound failure; Reduced Rate Leakage. Material misaligned some.

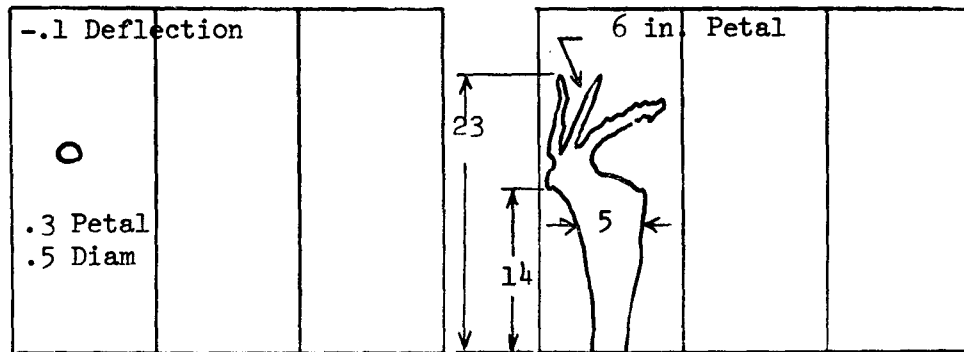
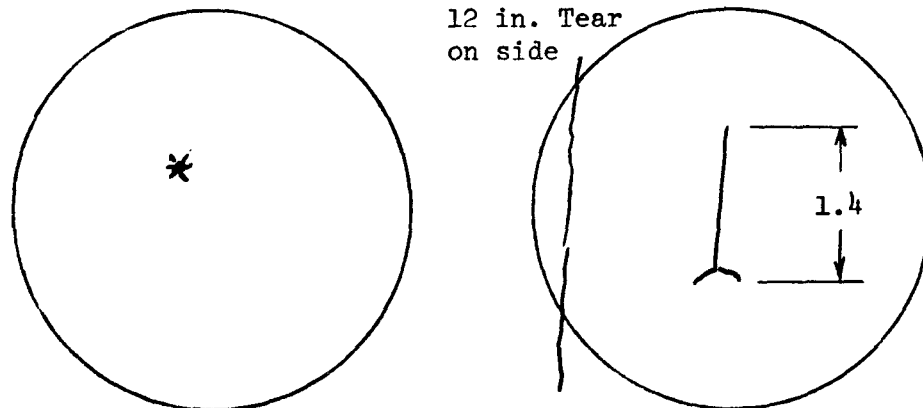
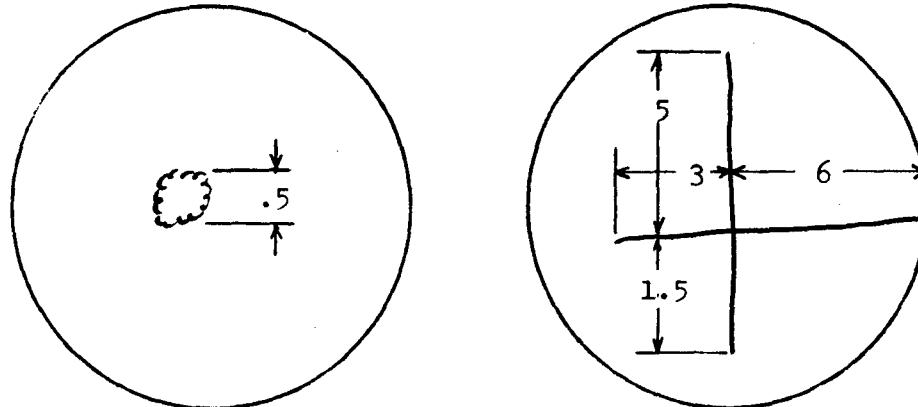
The skin was cored and deflected inward. Also .3 petals occurred. The backing board was frayed the size of the projectile. The self-sealing material sealed dry immediately, but a vacuum was pulled in the tank by the exit failure immediately.

The skin failed top to bottom. The backing board split out as shown. The self-sealing material was slit, with the wound misaligned. Also the sealant was not activated. The edge of the material was torn approximately 12 inches long. The skin was badly cored and petaled.

Had to replace the complete rear panel combination to continue test. Leakage 4-5 gallon/minute at 0 pressure. Round struck steel support angle with a glancing flow.

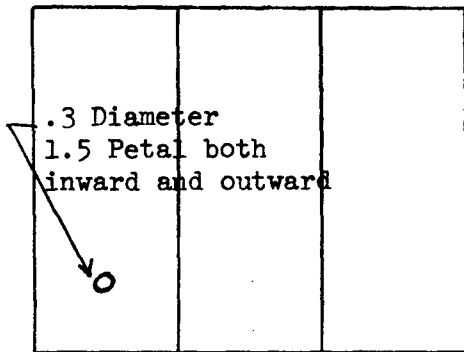
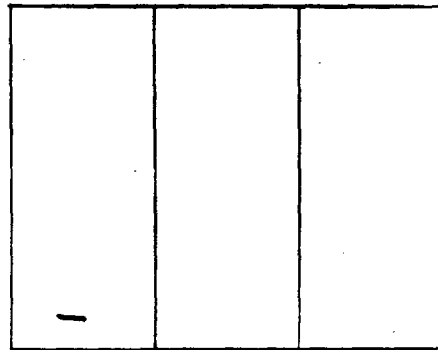
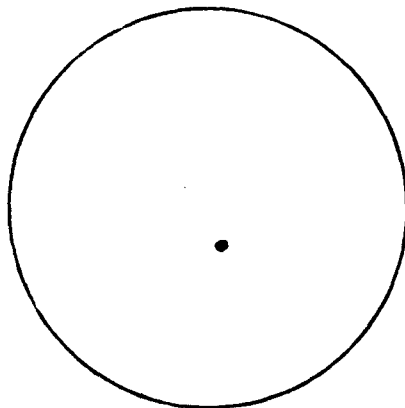
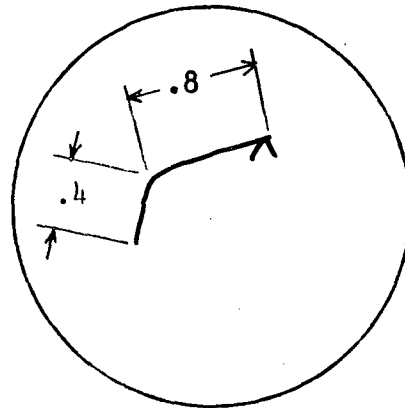
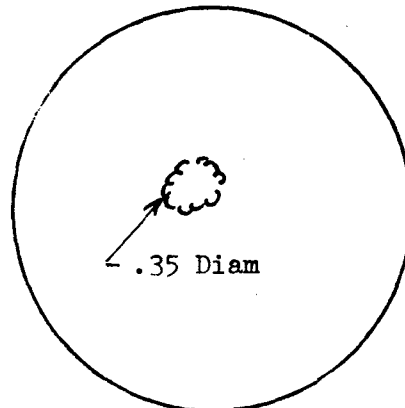
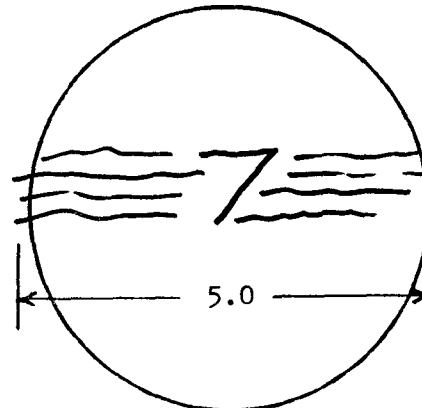
ROUND NUMBER T 78

No skin installed. The backing board frayed badly but did maintain some support. The self-sealing material slit and was misaligned. Leakage was 1-2 gallon/minute at 2 psi. No possible seal. Leakage was at least twice that of Round T 76. At 0 pressure exit wound still sprayed fuel. On break down - examined the whiffle balls in the projectile path. Some were just punctured while others were exploded. There was no apparent effect of using the whiffle balls.

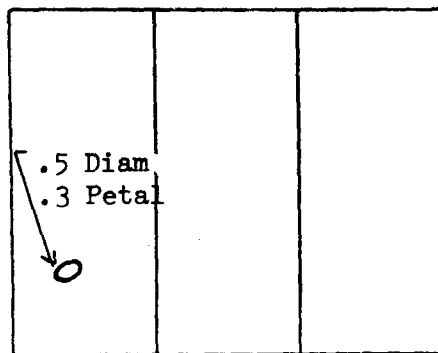
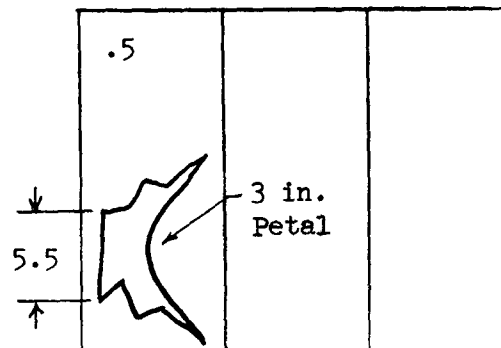
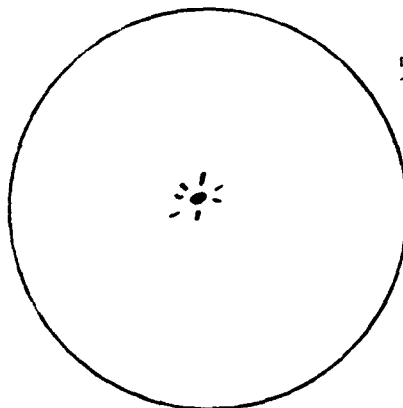
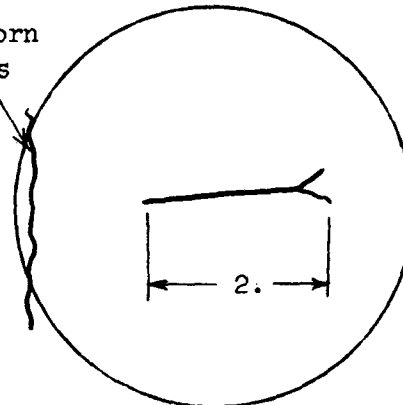
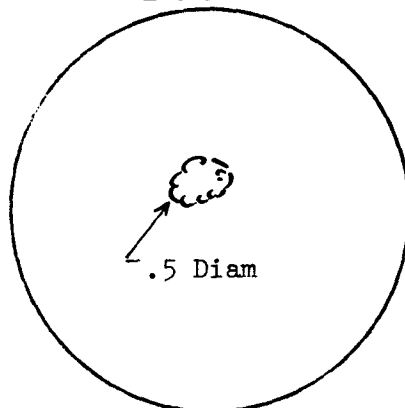
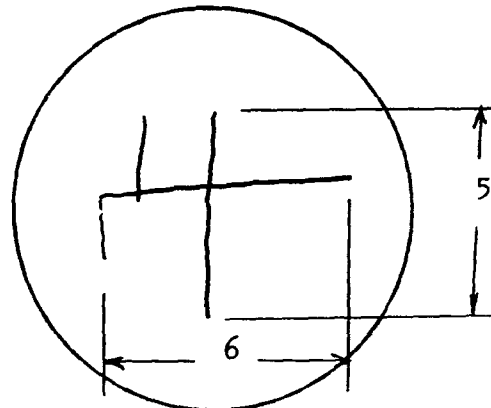
ROUND NUMBER T 79

Entrance: Straight 7 inches high 11 inches fuel head. The skin was cored and petaled .3 inches high. The backing board was frayed the size of the projectile. The self-sealing sealed with only a trace of fuel leakage.

Exit: Tumbled 6 inches high  
The skin was split and petaled. The backing board also split out. The self-sealing material was slit and the wound misaligned. However, the sealant was partially activated. The edge of the material was torn for approximately 5 inches. Leakage was 4-5 gallon/minute at 2 psi and 2-3 gallon/minute at 0 psi. Thus, the foam did help some in the self-sealing process. The round also struck the steel support angle.

Side Torn  
5 Inches

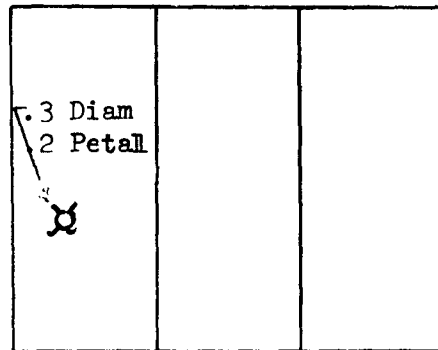
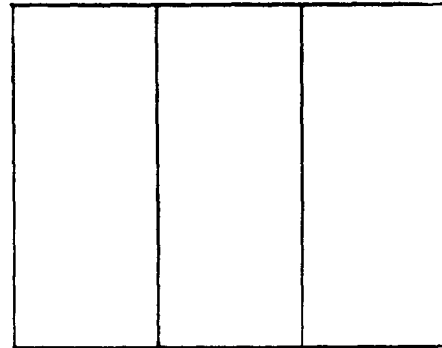
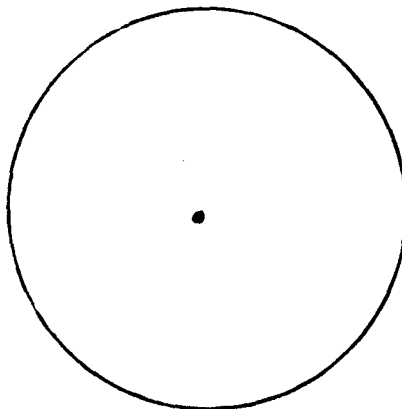
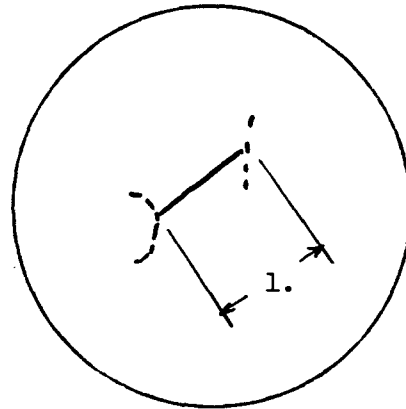
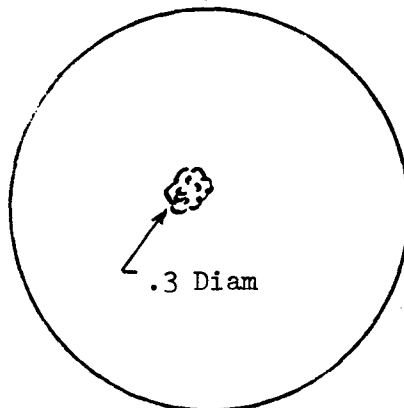
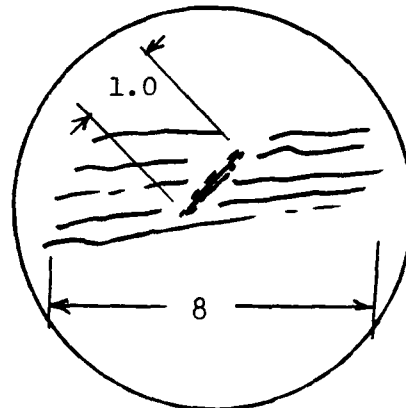
BLOCK NUMBER B 52  
ROUND NUMBER T 80

Entrance: 11.5 inches high straight 6.5 inches fuel head. The skin was cored with a few cracks (small). The backing board was frayed the size of the projectile. The self-sealing sealed dry with no trace of fuel leakage.

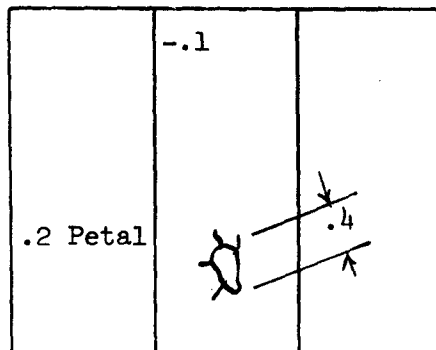
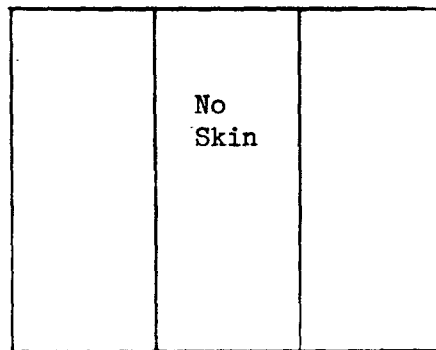
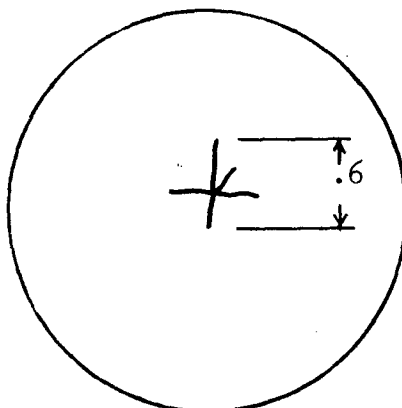
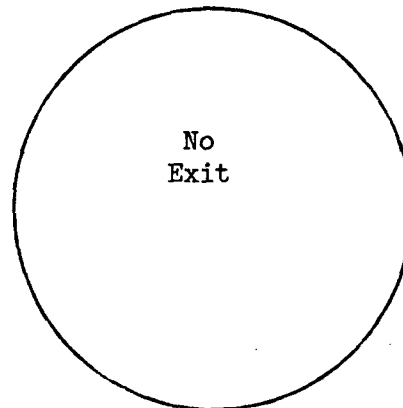
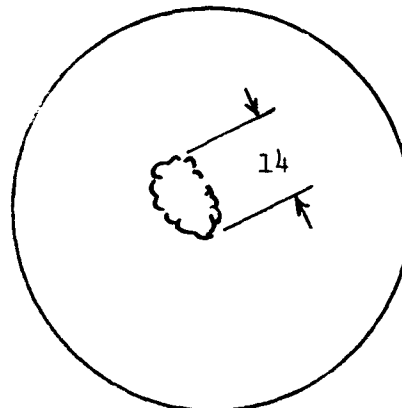
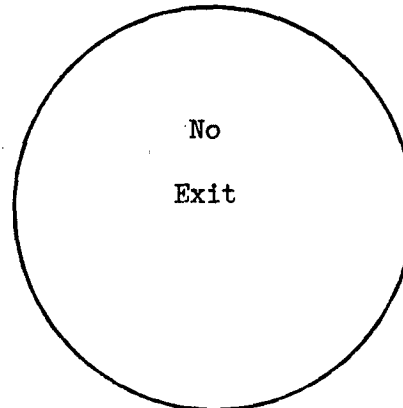
ROUND NUMBER T 81

Entrance: Over tumbled and **base forward 7.5 inches high. 10.5 in. fuel head.** The skin was cored and cracked with inward deflections. The backing board was frayed the size of projectile 1/3 tumbled. The self-sealing material sealed immediately dry but became damp after 4 minutes. The **pressure** was reduced to zero at 3 minutes.

Exit: None. No damage observed.

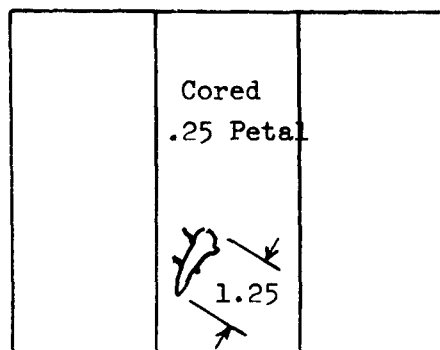
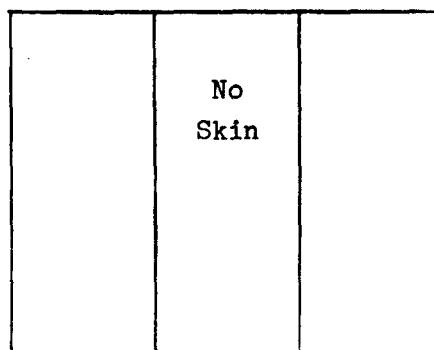
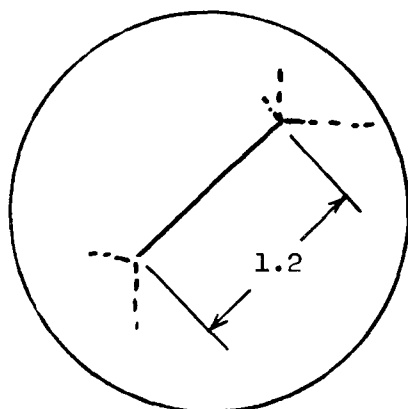
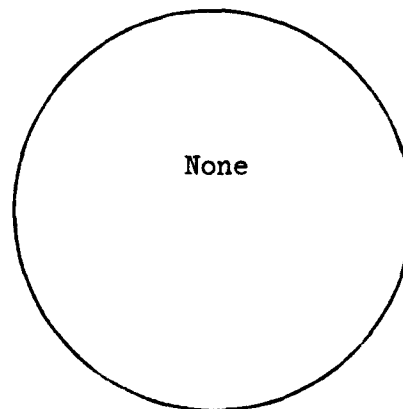
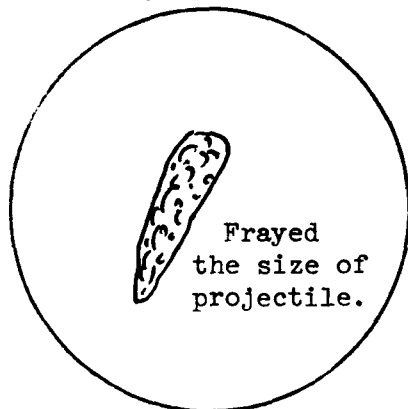
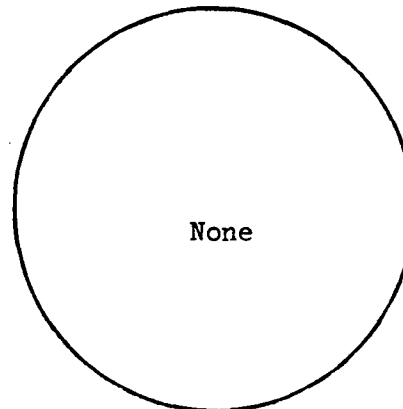
ROUND NUMBER T 82

Fully tumbled 13.5 inches below fuel surface.  
Saw flash on skin as entrance occurred. The skin was cored and petaled .25 high. The backing board was only frayed to the size of projectile. The self-sealing sealed damp immediately and dried when the pressure was reduced to zero after 3 minutes. Only leakage was a few drops.
